Manhole Inspection Summary

Manhole # S15UU_016MH

Insp Date: 11/11/08 1:26 PM

Location Address: **3006 DRUID PARK DR**

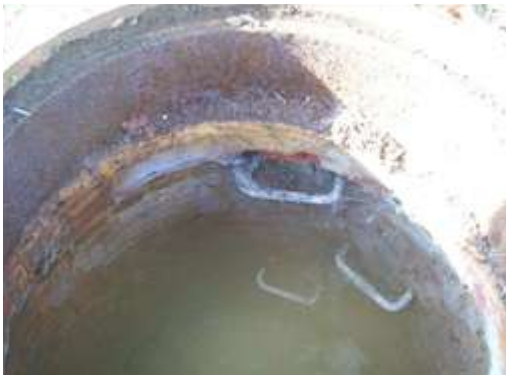
Defect 1

Frame Offset: **4** (in.) Condition: ☒ Sound ☐ Cracked ☐ Leaks

FRAME OFFSET

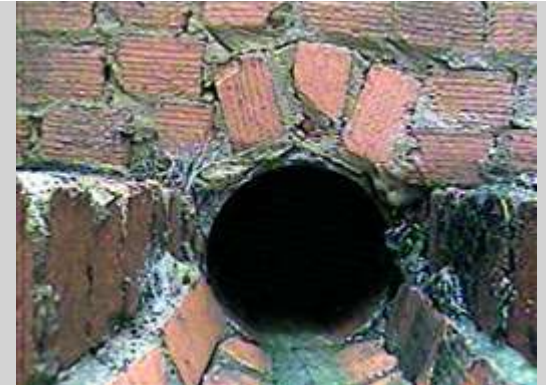
12 O'Clock Outflow

8 in. Circular Gravity Sewer
Pipe Out @ 12 O'Clock

Pipe Height: (in.) Direct
Pipe Material: **Clay** ☐ Pipe Lined
Invert Depth: **6.75** (ft.) Flow Characteristics: **Slow**
Deposits: ☒ None ☐ Mud ☐ Sludge ☐ Debris ☐ Grease
Silt Depth: (in.) Deposits Extent:
Infiltration: **None** Pipe Seal Cond: **Unknown**

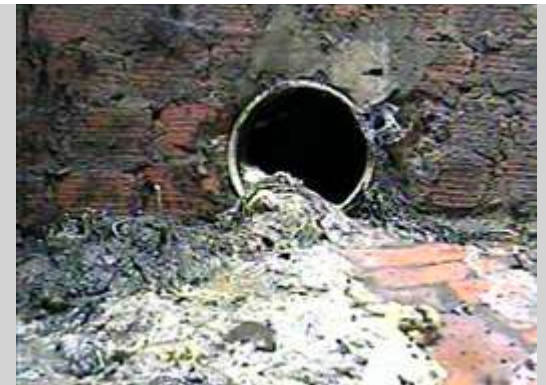
3 O'Clock Inflow

6 in. Circular Gravity Sewer
Pipe In @ 3 O'Clock

Pipe Height: (in.) Direct
Pipe Material: **PVC** ☐ Pipe Lined
Invert Depth: **6.05** (ft.) Flow Characteristics: **Slow**
Deposits: ☐ None ☐ Mud ☐ Sludge ☒ **Debris** ☐ Grease
Silt Depth: **1** (in.) Deposits Extent: **Medium**
Infiltration: **None** Pipe Seal Cond: **Sound**

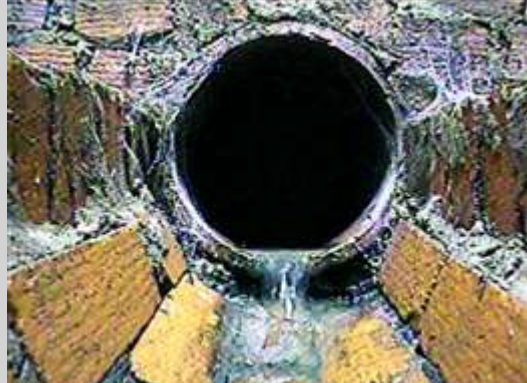
6 O'Clock Inflow

Infiltration: **None** Pipe Seal Cond: **Cracked**
